Flight Safety Investigation Report

**CANADIAN FORCES
FLIGHT SAFETY INVESTIGATION REPORT (FSIR)**

FILE NUMBER:	1010–CT156102 (DFS 2-2-2)
FSOMS IDENTIFICATION NUMBER:	159282
DATE OF REPORT:	27 April 2016
OCCURRENCE CATEGORY:	"A"
AIRCRAFT TYPE:	CT156 Harvard II
AIRCRAFT REGISTRATION NUMBER	CT156102
DATE OF OCCURRENCE:	24 January 2014
TIME OF OCCURRENCE (L):	12:18 L
LOCATION:	15 Wing Moose Jaw, SK
OPERATOR:	2 CFFTS, 15 Wing

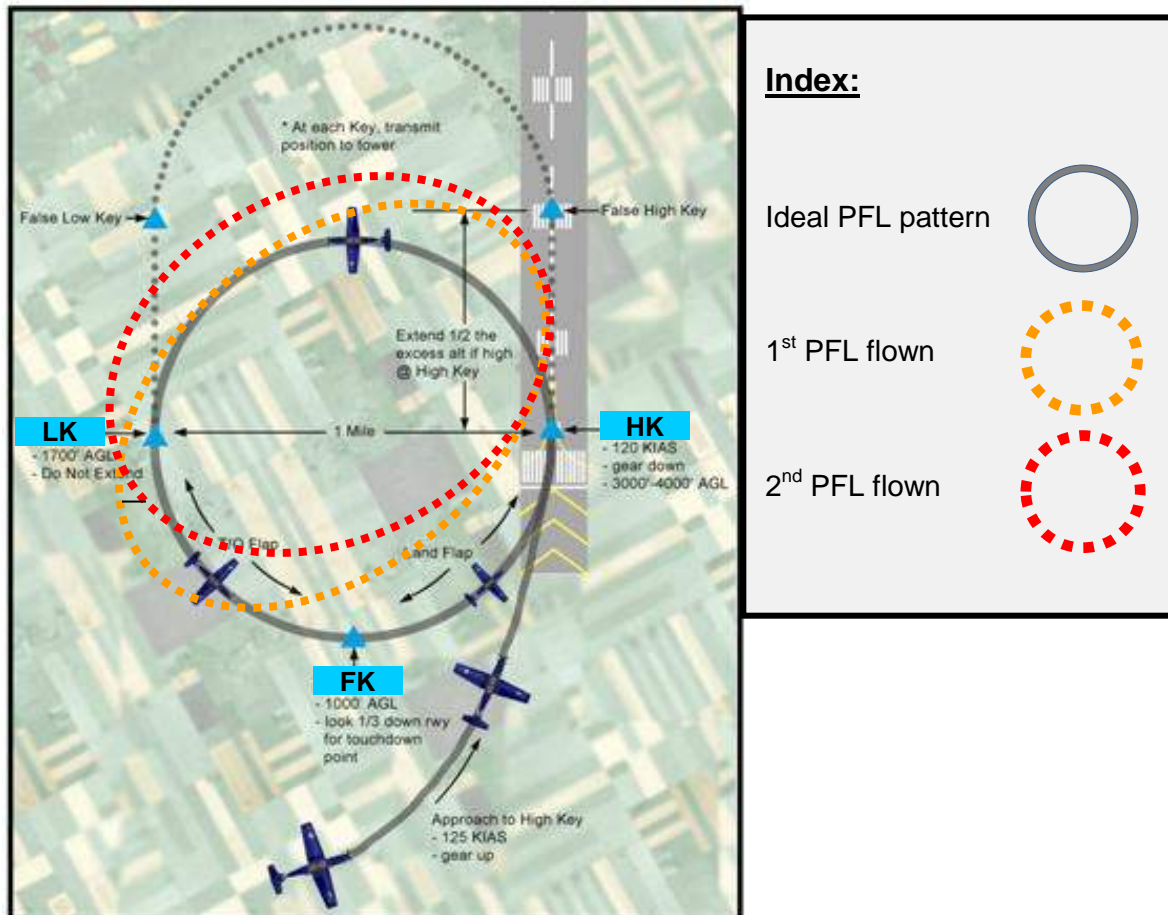
Figure 1. PFL pattern with overlay of approximate flight paths

1.1.8. Figure 1 illustrates the basic PFL pattern. The shaded circular line with aircraft along it depicts the ideal PFL pattern. Included are two approximated ground tracks flown during this particular sortie:

1.1.9. Lack of sufficient correction for the strong northwesterly wind caused the first PFL to be elongated for the low key (LK) position, farther downwind and wider than ideal. Landing gear was selected down approaching LK in accordance with (IAW) the Harvard II Standard Manoeuvre Manual (SMM). Having recognized the effect of the strong wind at LK, the SP turned more directly towards the runway to cut inside of the final key (FK) position. No flap selections were made during this PFL and, realizing that a safe landing was not assured due to a lack of altitude when approaching the runway, the SP initiated a go around.

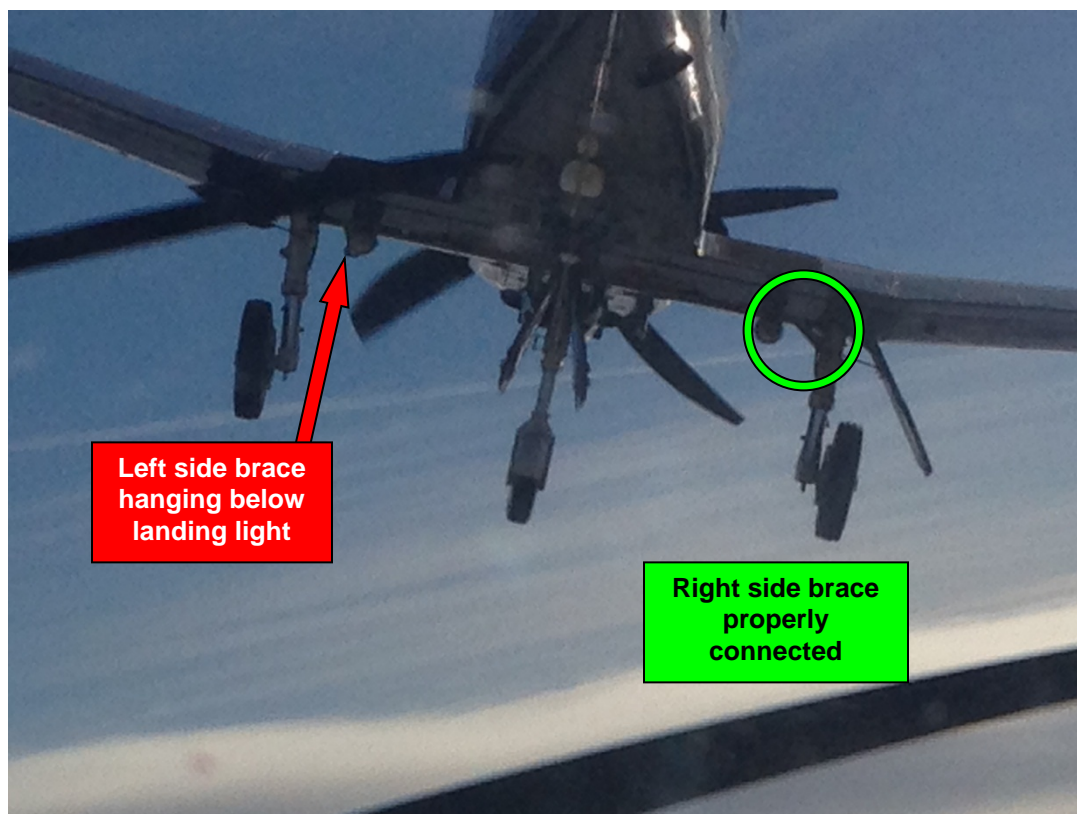
Figure 2. Chase plane photo showing detached LMLG side brace

1.1.14. A Harvard II chase aircraft joined up to visually inspect the landing gear and confirmed that the LMLG appeared “bent”. Photos of the aircraft’s landing gear were taken [Figure 2] before the chase aircraft returned to base. The photos clearly depicted that the LMLG side brace was detached from the LMLG strut. With damage of this nature there was no way to lock the LMLG down because the downlocks for the main landing gear (MLG) are contained within the hydraulic actuators which control the struts through the now disconnected side brace.

1.12.2. Landing gear components that were recovered from the runway included nine fragments of the left wheel rim and a bushing used to help secure the LMLG strut to the side brace. These components were recovered near tire marks on the runway that indicated the touchdown points of the aircraft's main and nose landing gear.

1.12.3. The bolt which secures the side brace to the LMLG was not recovered. Investigation by Quality Engineering Test Establishment (QETE) found sufficient evidence to conclude that this bolt failed in tension overload during the hard landing allowing the side brace which controls movement of the LMLG strut and provides a down lock to become detached.

2.8.2. The NRC calculated the descent rate at the point of impact of the hard landing to be 1700 feet per minute; an impact of approximately +4G. The aircraft attitude at the point of impact was 6° nose up and 8° left wing down, causing the LMLG to absorb the most kinetic energy. QETE concluded that the excessive sink rate - over twice the design limit of 780 feet per minute - caused a rim burst of the left wheel segment preventing wheel spin up and failure of the side brace attachment bolt under tension, allowing the lower side brace to separate from the strut.

2.8.3. The investigation determined that the LMLG side brace failure occurred as a result of the hard landing that exceeded design limits. The side brace separation meant that the LMLG could not retract or remain in a down lock position for a safe gear down landing.

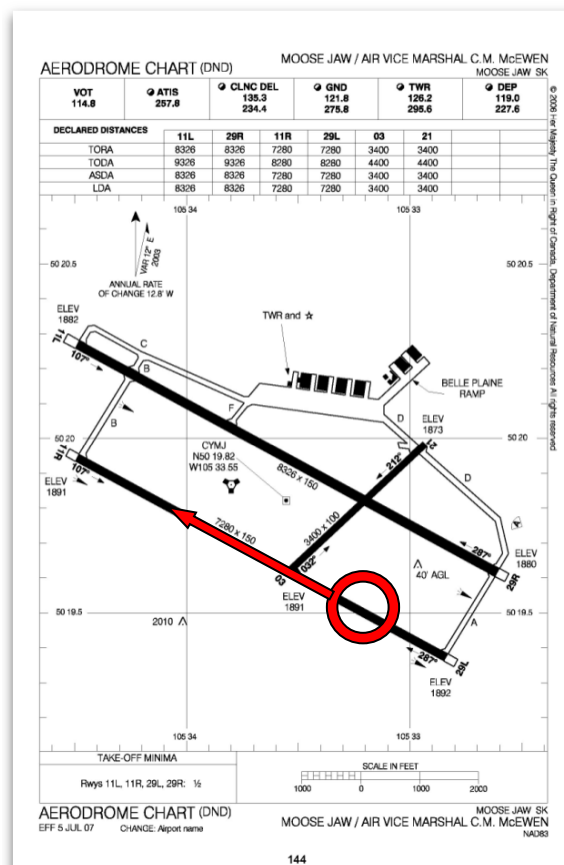
Figure 3. CYMJ Aerodrome Chart

1.10.1. CYMJ has two principal parallel runways: 11/29 left (L) and right (R). Rwy 29L and 29R were both active at the time of the accident [Figure 3].

Circle depicts approximate touch down point during the hard landing.
Arrow depicts direction of flight.

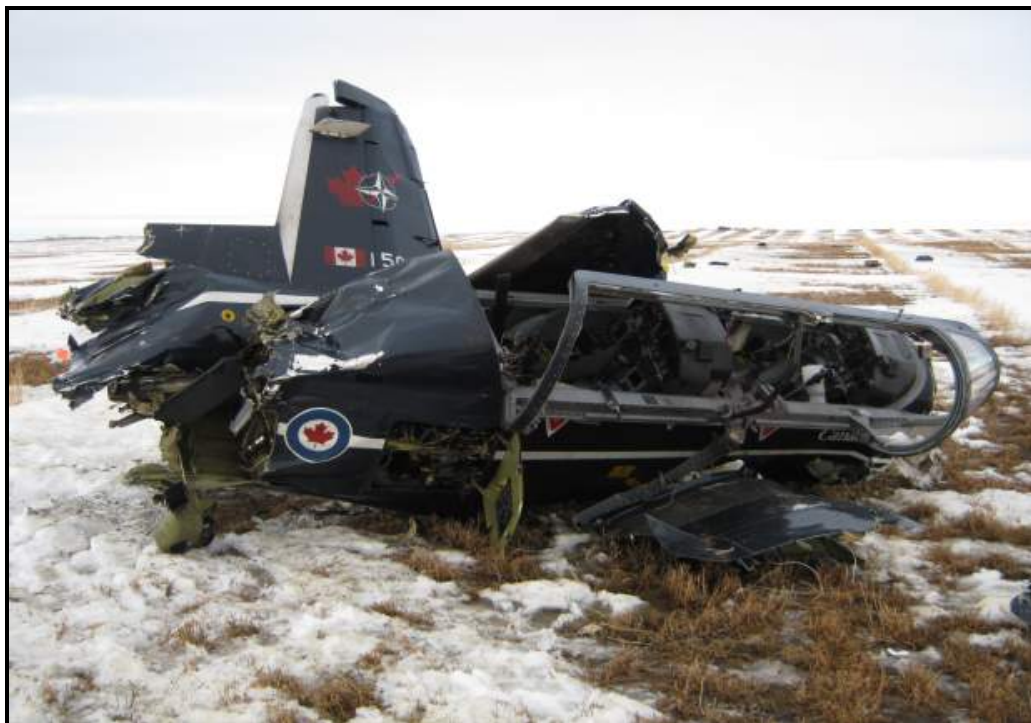
Figure 5. CT156102 Main Wreckage Site

1.14.1. There was no post-crash fire.

1.14.2. There were two pyrotechnic devices still live in the airframe. This is normal following an airborne ejection as these live devices are designed only for emergency ground egresses. As 15 Wing does not have onsite explosive ordnance disposal (EOD) personnel, all live devices were removed by Aerospace Engineering Test Establishment (AETE) personnel and rendered safe by 17 Wing EOD personnel.

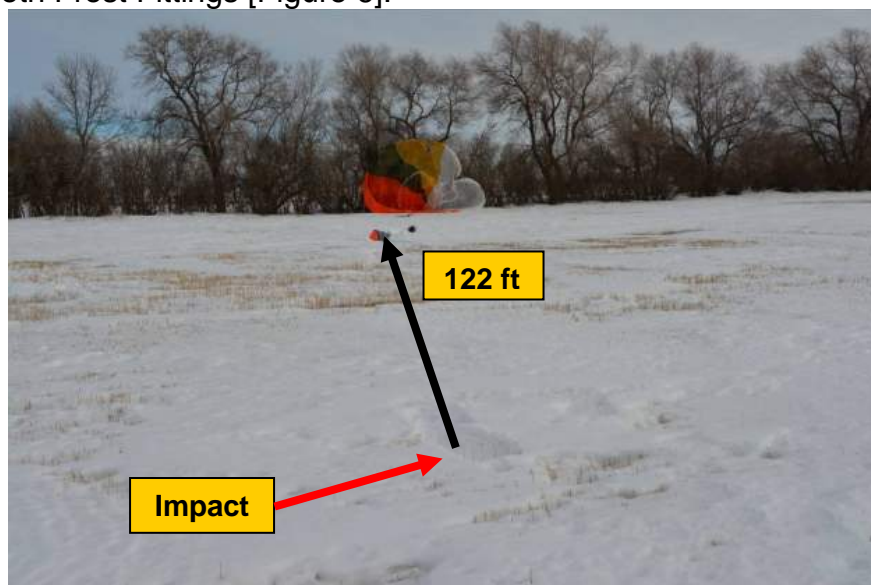
Figure 6. SP landing site showing drag distance

1.15.5. The SP landed in a field facing out of wind and received minor injuries due to tumbling while being dragged by the parachute. The SP was dragged 122 feet before being able to establish a stable drag position and release both Frost Fittings [Figure 6].

2.11.5. The investigation also determined that the SP was injured upon landing likely as a result of an elevated speed over the ground due to not pulling the appropriate riser early enough to turn fully into wind in order to reduce ground speed prior to landing. The investigation concluded that additional parachute training for all ejection seat aircrew would be beneficial in response to this deficiency. It is recommended that modern parachute training be researched as a possible solution to this issue.
