Flight Safety Investigation Report

**CANADIAN FORCES
FLIGHT SAFETY INVESTIGATION REPORT (FSIR)**

FILE NUMBER:	1010–CT156102 (DFS 2-2-2)
FSOMS IDENTIFICATION NUMBER:	159282
DATE OF REPORT:	27 April 2016
OCCURRENCE CATEGORY:	"A"
AIRCRAFT TYPE:	CT156 Harvard II
AIRCRAFT REGISTRATION NUMBER	CT156102
DATE OF OCCURRENCE:	24 January 2014
TIME OF OCCURRENCE (L):	12:18 L
LOCATION:	15 Wing Moose Jaw, SK
OPERATOR:	2 CFFTS, 15 Wing

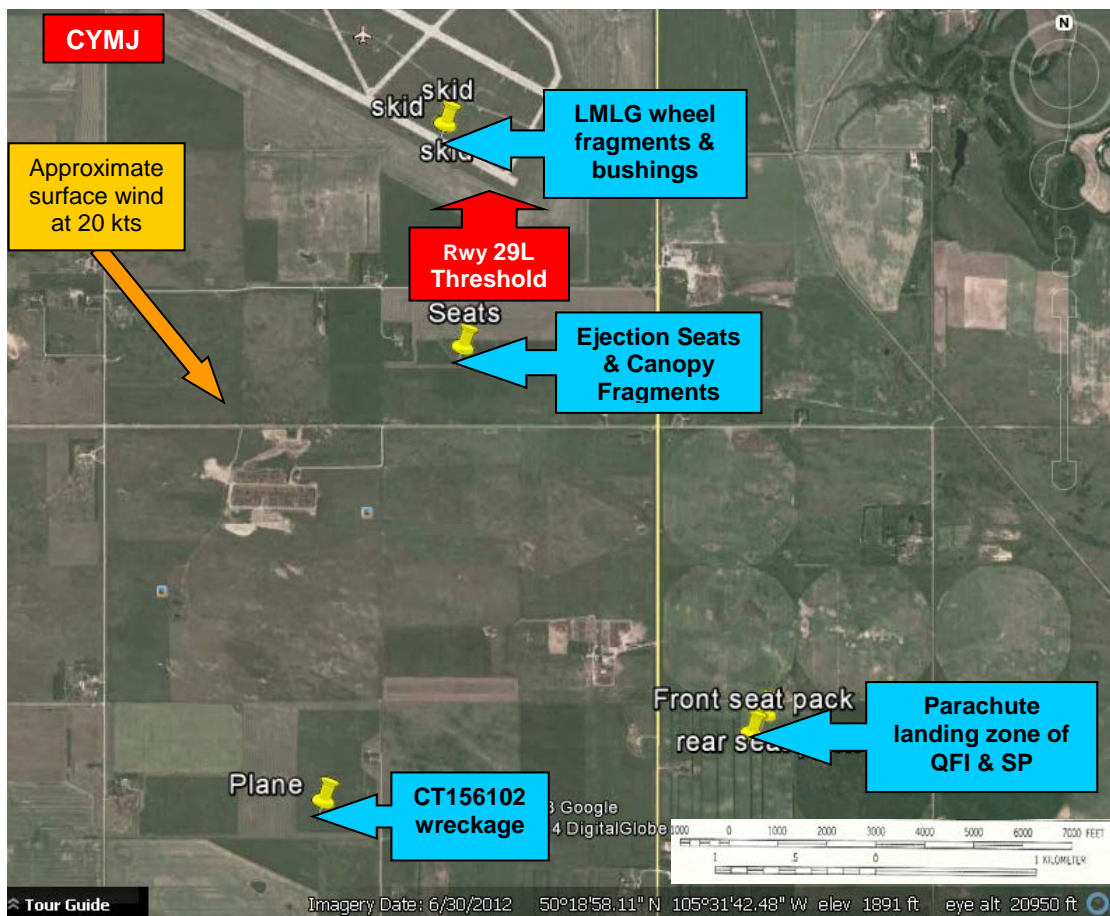
1.12.1. There were four separate aircraft wreckage locations [Figure 4]: landing gear components on runway 29L; the ejection seats and canopy fragments; the QFI and SP parachute landing sites, and; the main Harvard II aircraft crash site [Figure 4].

1.12.2. Landing gear components that were recovered from the runway included nine fragments of the left wheel rim and a bushing used to help secure the LMLG strut to the side brace. These components were recovered near tire marks on the runway that indicated the touchdown points of the aircraft's main and nose landing gear.

1.12.3. The bolt which secures the side brace to the LMLG was not recovered. Investigation by Quality Engineering Test Establishment (QETE) found sufficient evidence to conclude that this bolt failed in tension overload during the hard landing allowing the side brace which controls movement of the LMLG strut and provides a down lock to become detached.

Figure 4. Satellite photo with indications of key locations
